**Rain Penetration Tests on
Manthorpe Mini Castellated
Vent Tile with 15" x 9" Format
Roof Tiles**

Prepared for:
Ben Hales

Manthorpe Building Products
Ltd.

Report number 295-318

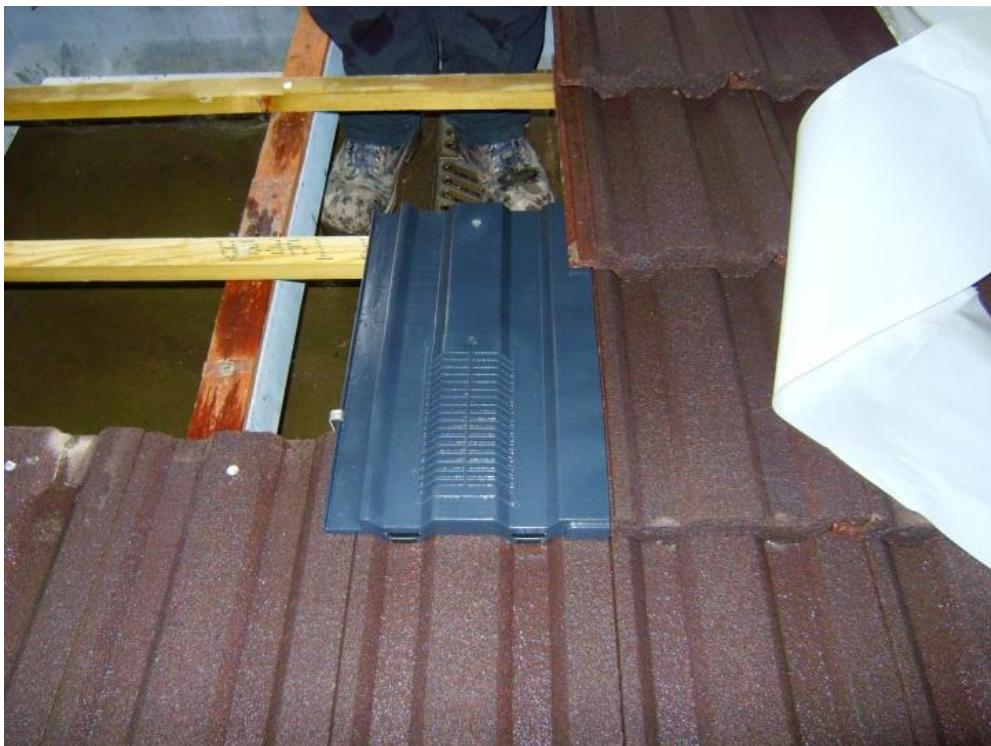
Figure 1 Vent tile being installed on the roof

The tiles and vents were installed on the BRE test rig by Manthorpe employees. Details of the tile fixing specifications are given in Annex A. For these tests a Marley Ludlow granulated finish concrete tile was used, these tiles are expected to be representative of the generic range of 15" x 9" tiles. Figure 1 shows the vent tile during installation.

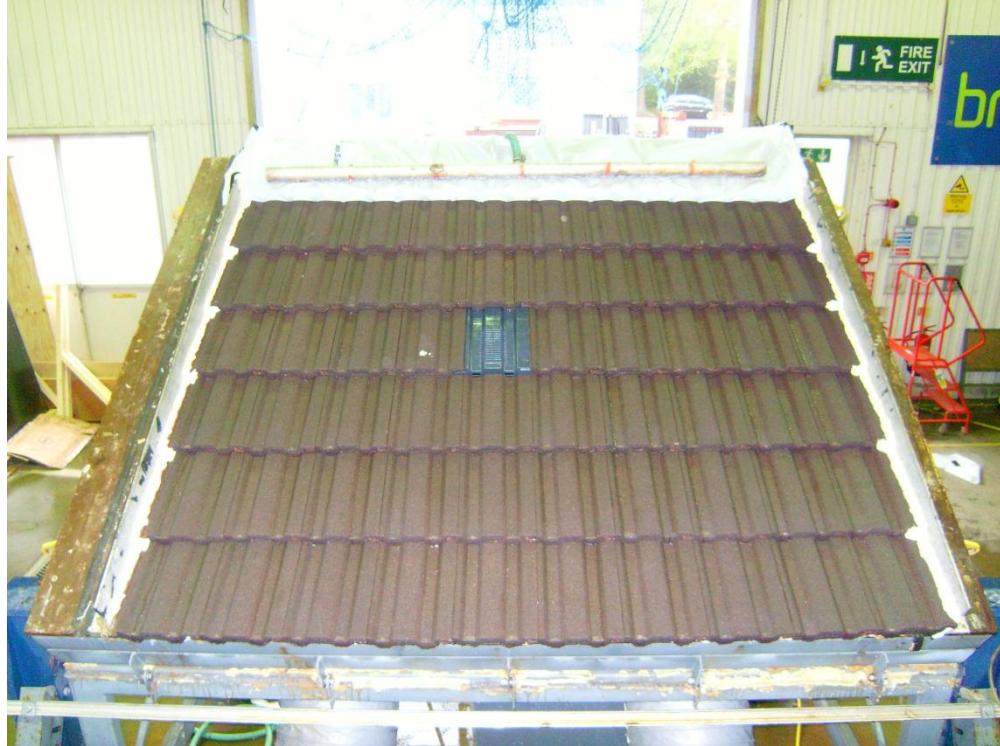
Figure 2 Manthorpe Mini Castellated Vent Tile with Marley Ludlow Plus tiles installed on the BRE driving rain test rig

The performance of the roof vent with tiles was investigated using a purpose-built monopitch test roof of nominal size 2m x 2m, at pitch angles of 17.5°, 22.5° and 30°. On the underside of the test roof, and central to it, a 1.8m wide x 1.6m long shallow Perspex box (open area 2.88m²) was mounted. It was this box that allowed the pressure underneath the tiles to be controlled. This test rig fully complies with the requirements laid down in FprEN 15601:2006 and has been calibrated to give the required uniformity of wind speed and rain flow across the test specimens. Results of the calibration tests on the BRE test rig and details of the turbulence intensity in the flow are presented in Annex B. Figure 2 shows the roof vent and tiles laid on the BRE test rig ready for test.

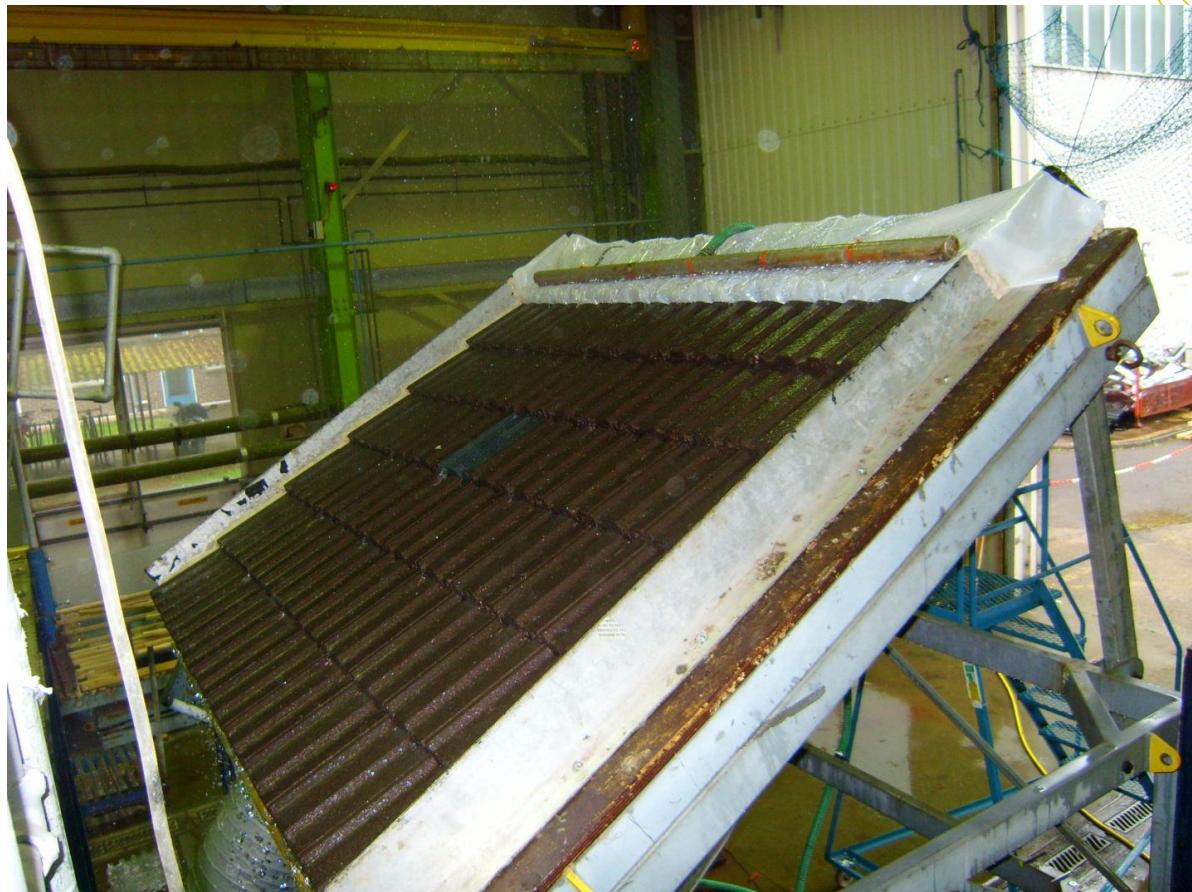
Figure 5 View of the vent and tiles under test

It can be seen from Table 1 and Figure 3 that the Manthorpe Mini Castellated Vent Tile is marginally better than the surrounding Marley Ludlow Plus roof tiles. At a roof pitch of 17.5° the pressure factors are 50.5Pa and 50Pa with and without the tile vents. At 22.5° pitch the pressure factors are 56Pa and 57.5Pa and at 30° pitch the pressure factors are 65.5Pa and 67.5Pa respectively with and without the tile vents. The log sheets in Annex A showing observations made during the testing show that no rain leakage was observed coming through the vent. Some water was observed leaking at the vent side interface with the surrounding roof tiles but this was similar to or less than the water leakage observed from the side locks of the surrounding roof tiles themselves. The Manthorpe Mini Castellated Vent Tile did not cause the Marley Ludlow roof tiles to leak earlier than they leaked without the vent in place. Figure 5 shows the vent and tiles under test.

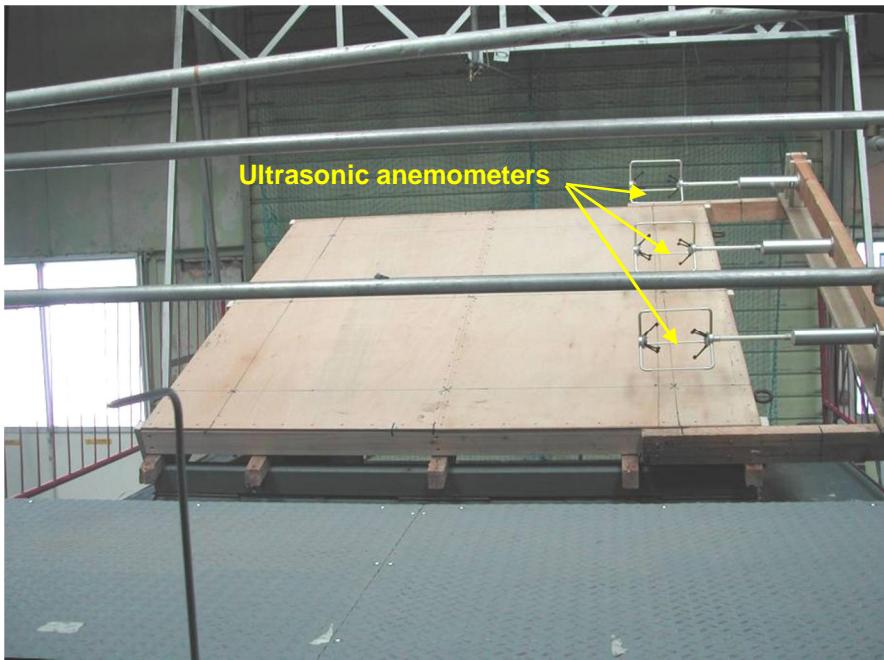
Figure B2 Calibration of the wind speed over the test specimen area

FprEN 15601 has specific calibration requirements for the test facility to ensure that the distribution and magnitude of the wind speed, driving rain and runoff water are all within required limits. The requirement for the wind speed generation is a fan system capable of generating wind blowing parallel to the rafters of the test specimen with a spatial variation of the wind speed over the specimen of not more than 10 %. This is achieved by measuring the wind speed at not less than 9 positions uniformly distributed at a height of 200 ± 10 mm over a flat boarded area which replaces the test specimen, at the relevant roof pitch. The calibration wind speed shall be 10 ± 0.5 m/s at the centre of the test specimen. Figure B1 shows the end of the BRE wind tunnel and Figure B2 shows the wind speed calibration of the BRE test rig using ultrasonic anemometers.

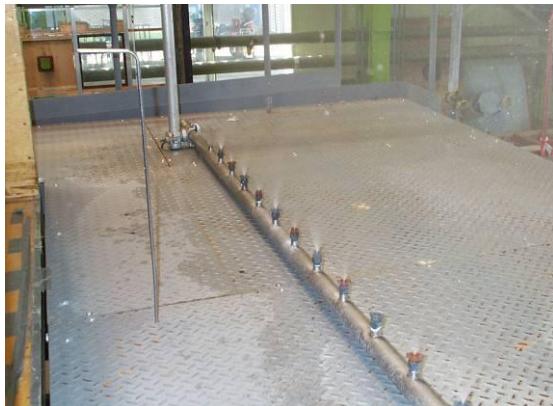
Figure B3 Bottom spray bar

Figures B3 to B6 show the calibration of the driving rain in the BRE test rig. The results of the calibrations for Sub-Tests A, B and C for the Northern European Coastal climate are shown in Table B2. From Table B2 it can be seen that the degree of variability in Sub-Tests A, B and C is close to but just within the allowable limit of $\pm 35\%$.

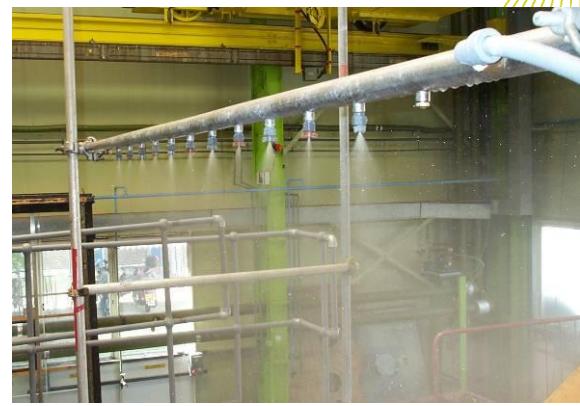
Figure B4 Top spray bar

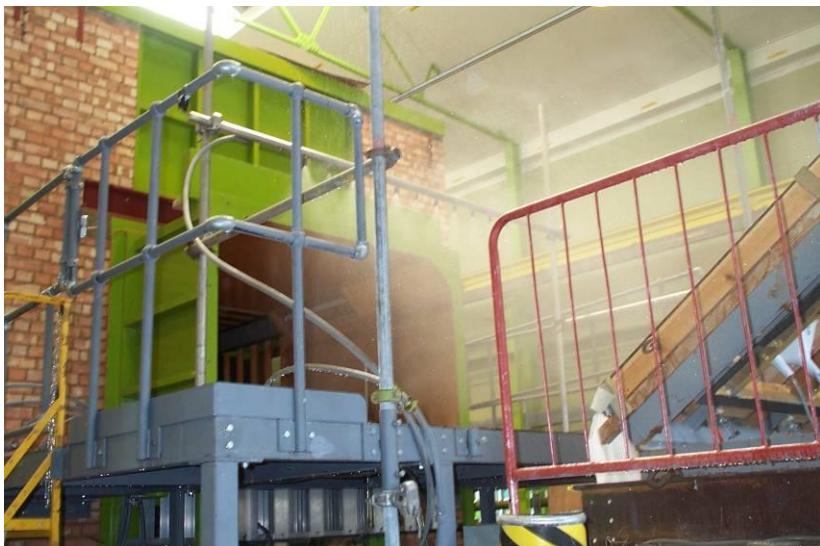
Figure B5 View of the test rig at the end of the tunnel

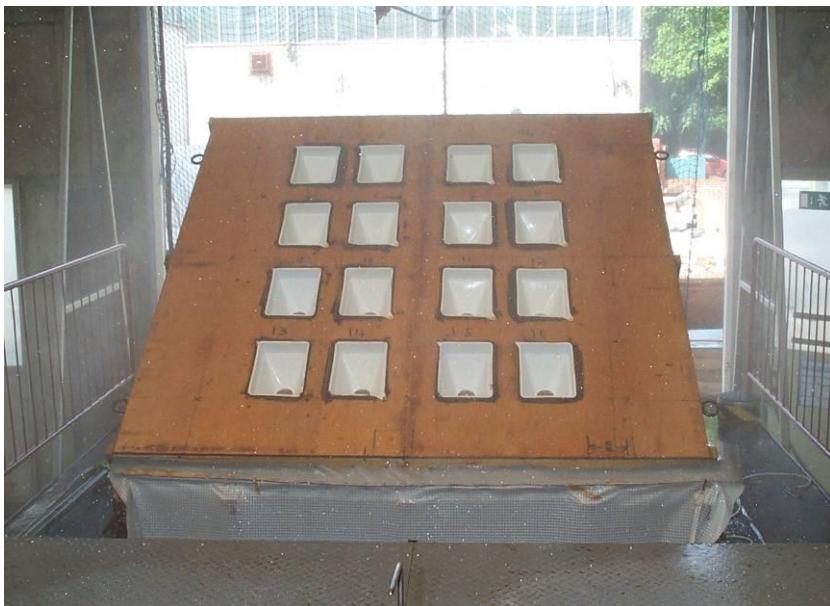
Figure B6 View of the 16 rainfall collection buckets on the test rig
